Manhole Inspection Summary

Manhole # S45MM_011MH

Insp Date: **3/25/08 10:13 AM**

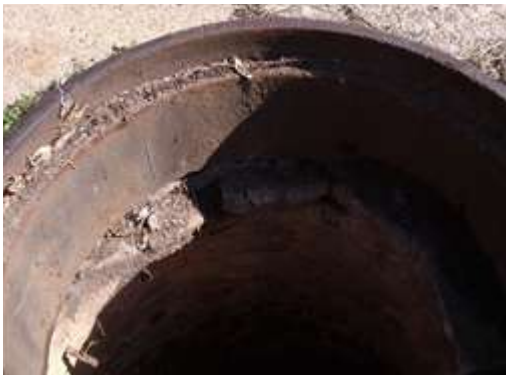
Defect 2

Offset: **3** (in.)

Offset

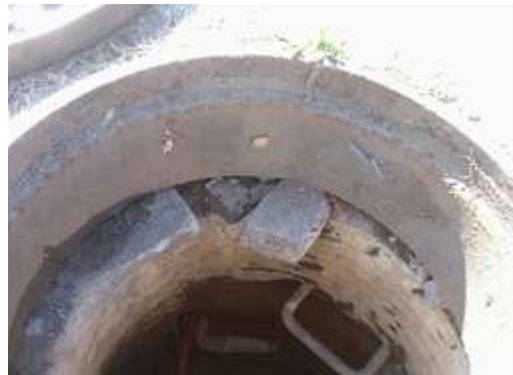
Defect 1

Loose Bricks

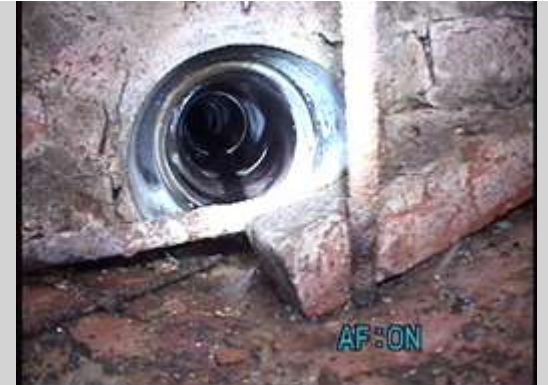
12 O'Clock Outflow

8 in. Circular Gravity Sewer
Pipe Out @ 12 O'Clock

Infiltration: **None** Pipe Seal Cond: **Sound**
